WATER VISION  
TECHNOLOGY

**To advance the Earth's resource resiliency  
through SAR analytics**

# After two decades of water loss management progress, why are leakage levels still so high?

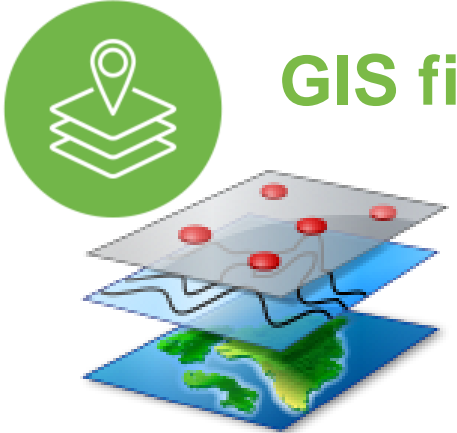
## GIS files

SHP and KML  
for the utility  
mapping

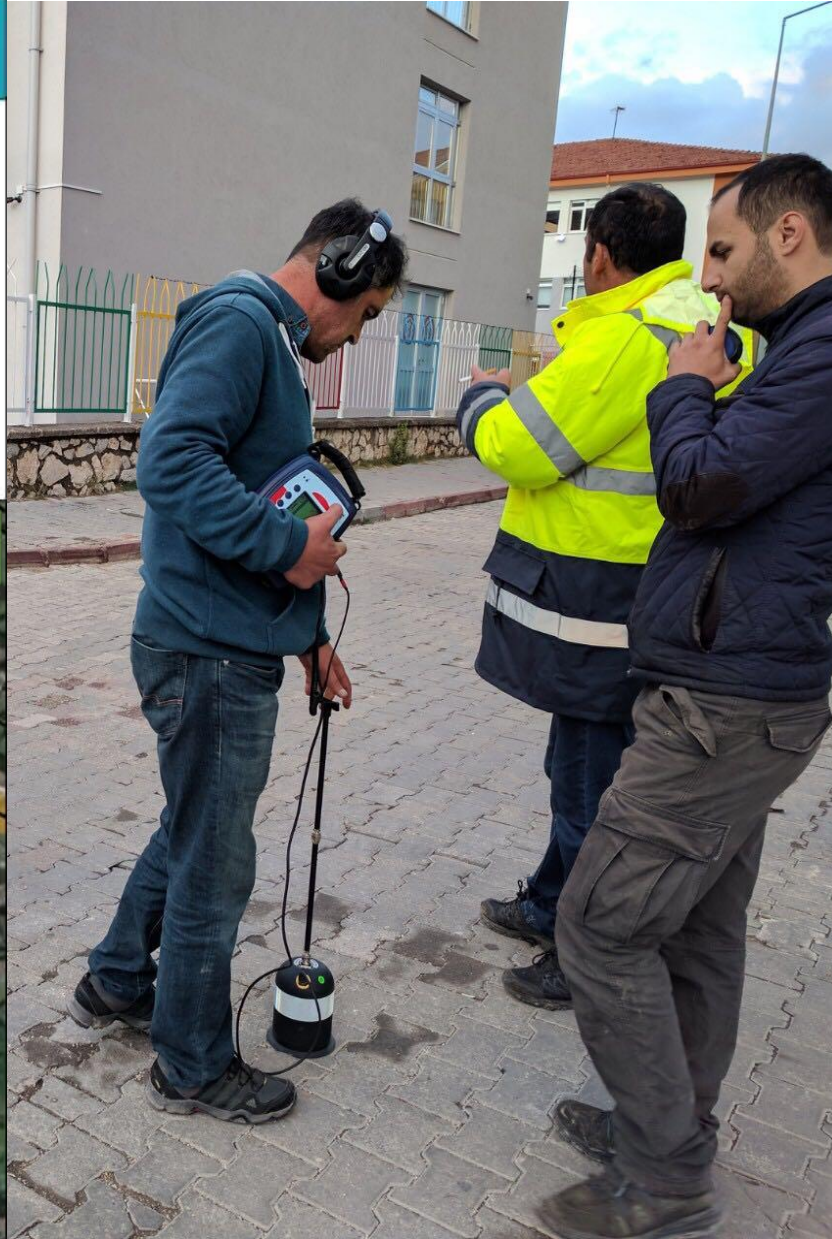
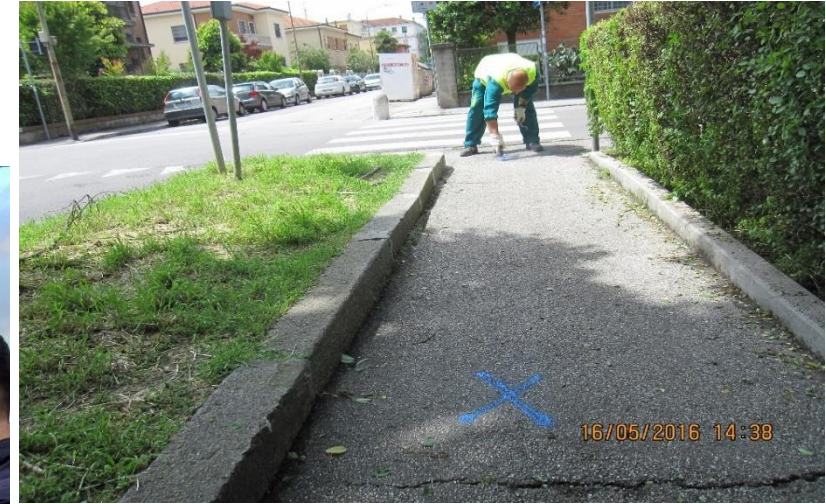
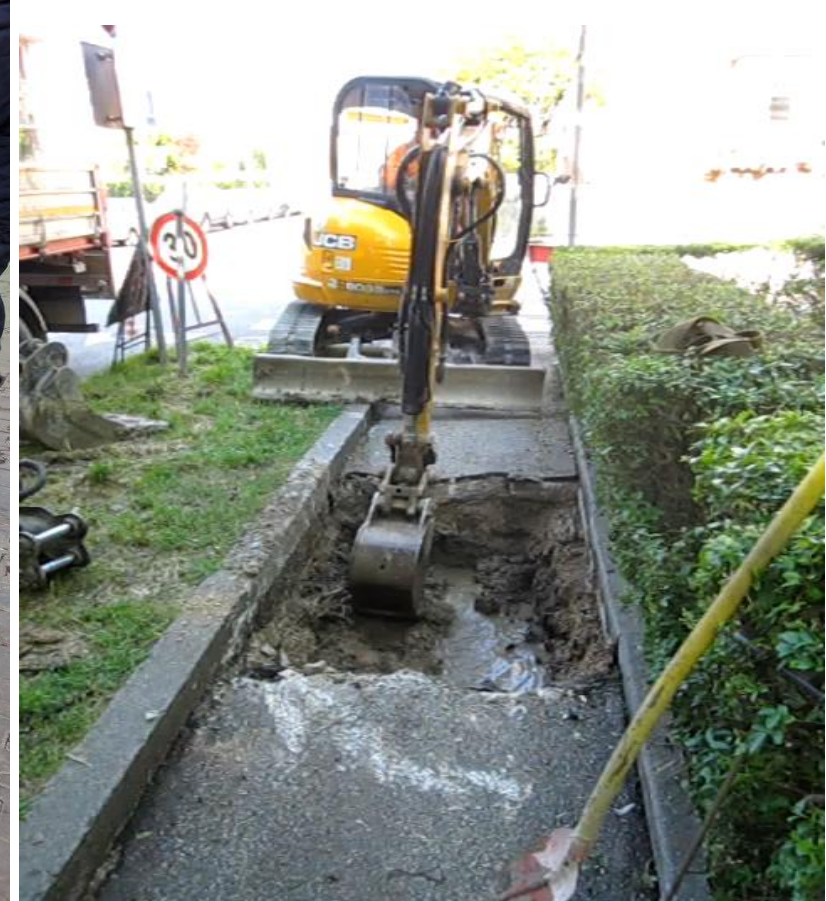
# Example step-by-step

**STW July 2018**  
**Finding: 10982**  
**110 Linton Rise, Nottingham NG3 7BY**  
**Image Date: 14-06-2018 Y: 52.95976, X: -1.11772**

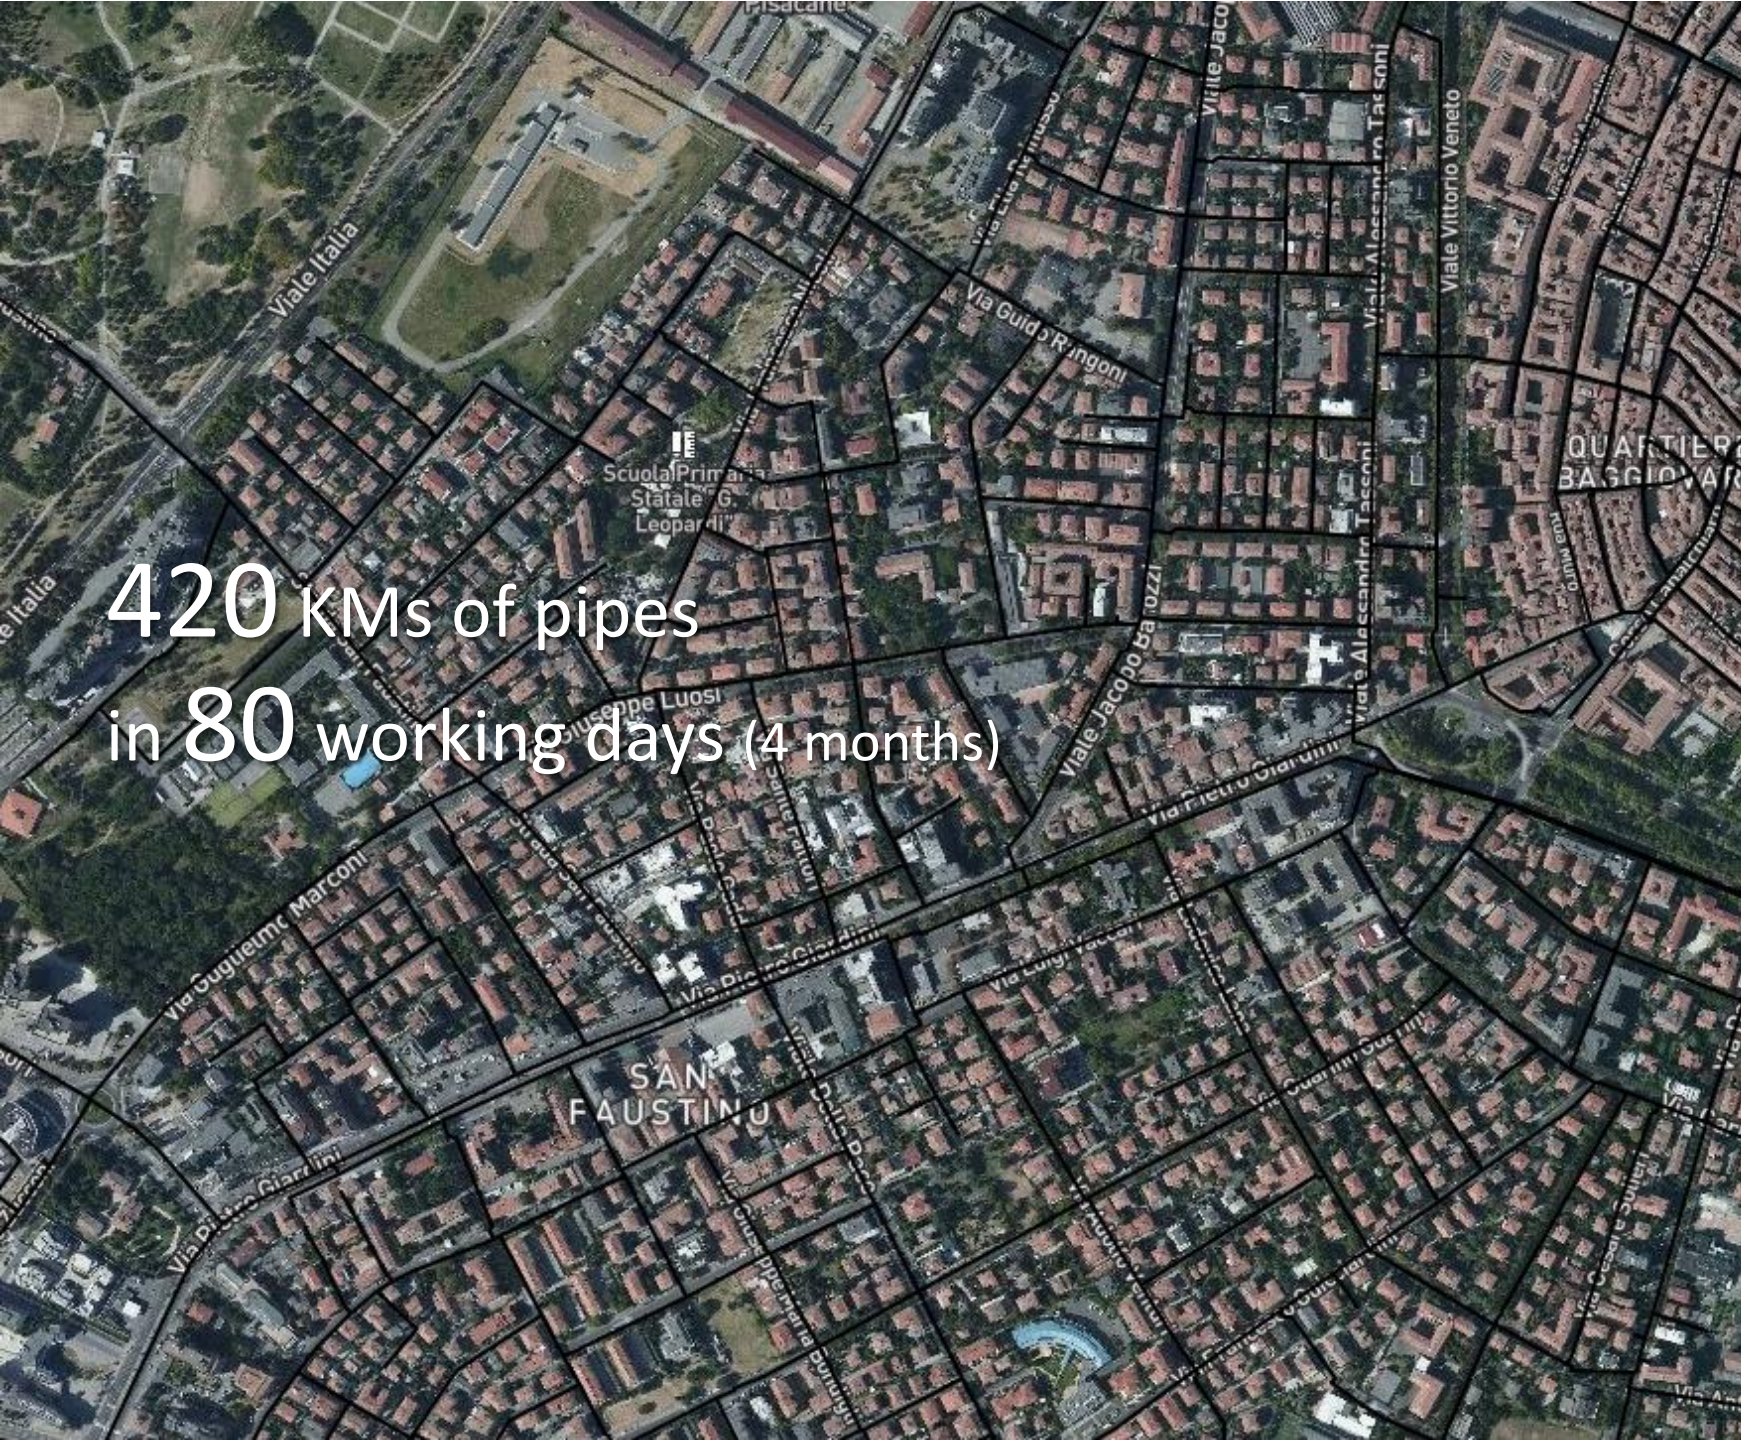
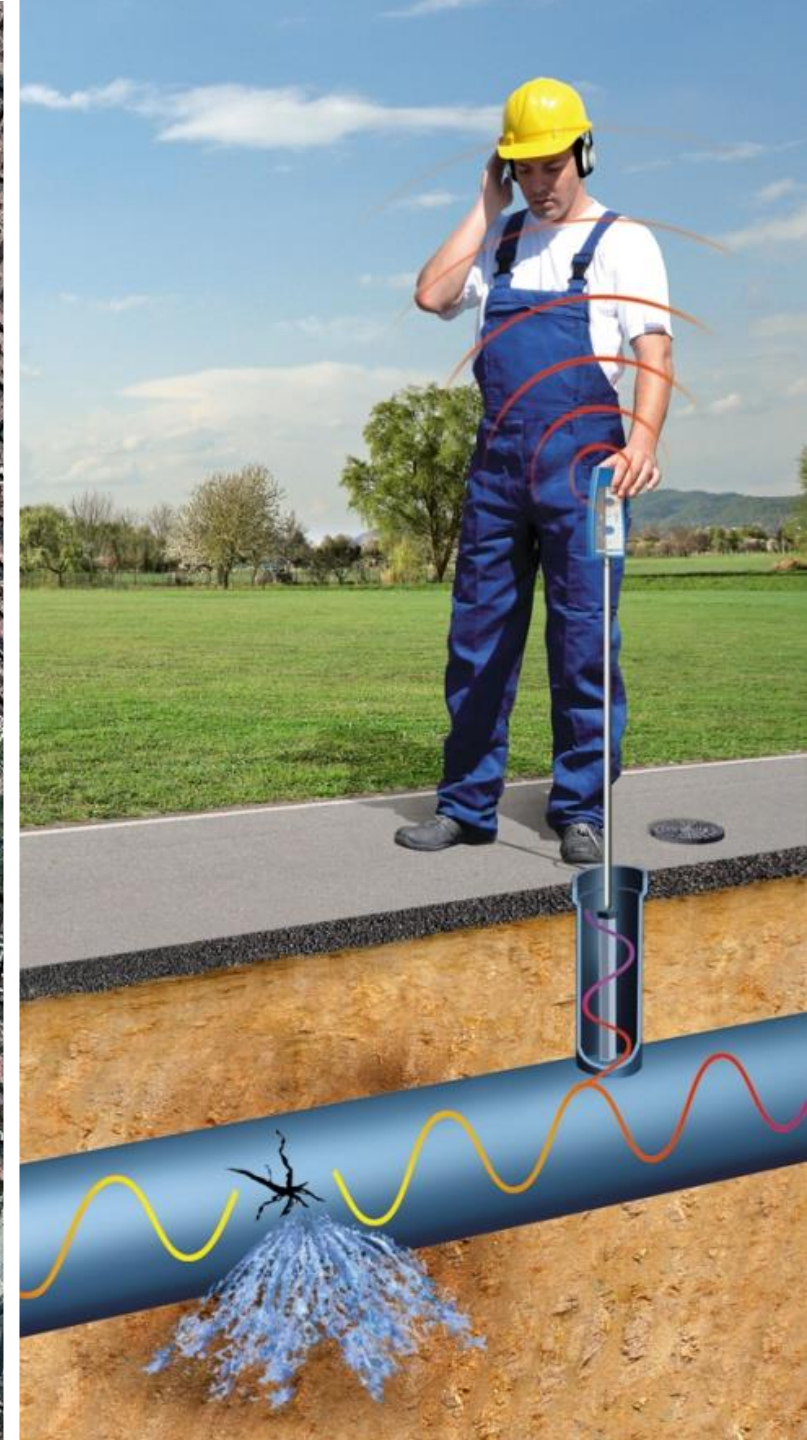
420 KMs of pipes  
in 80 working days (4 months)

420 KMs of pipes  
in 10 working days
