WATER VISION  
TECHNOLOGY

**To advance the Earth's resource resiliency  
through SAR analytics**

**The View is Better From Space**

# After two decades of water loss management progress, why are leakage levels still so high?

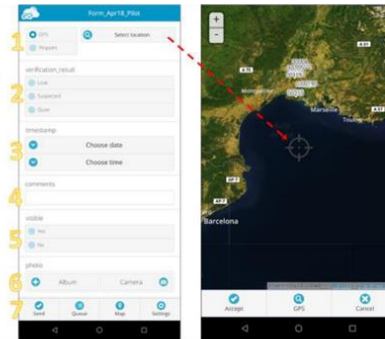
Data  
collector

• This is your main screen

1. Enter the location of a leak (via GPS or map location)
2. Enter the type of result
3. Time and date
4. Comments
5. If it is a leak → Visible or not
6. Add a photo
7. Press send

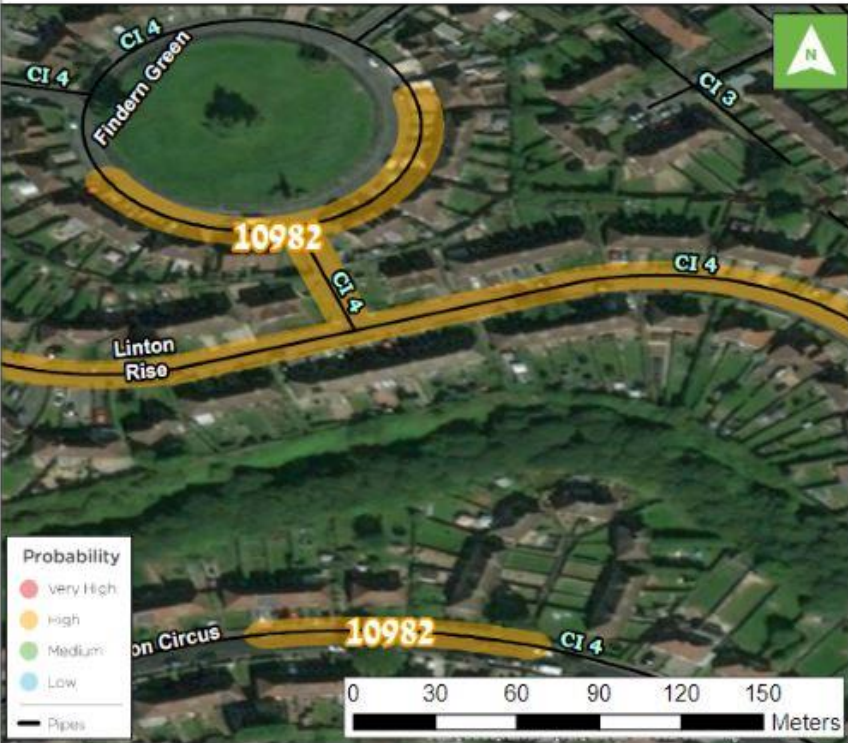
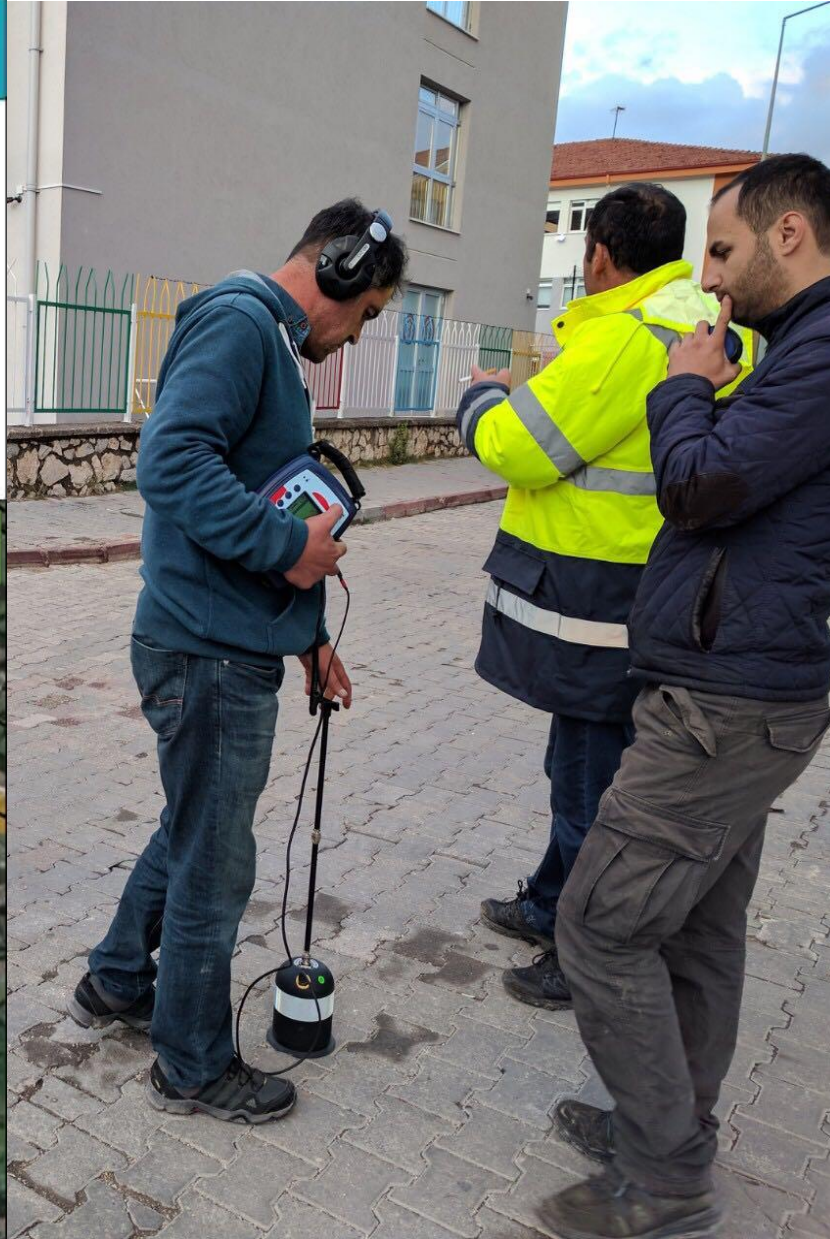
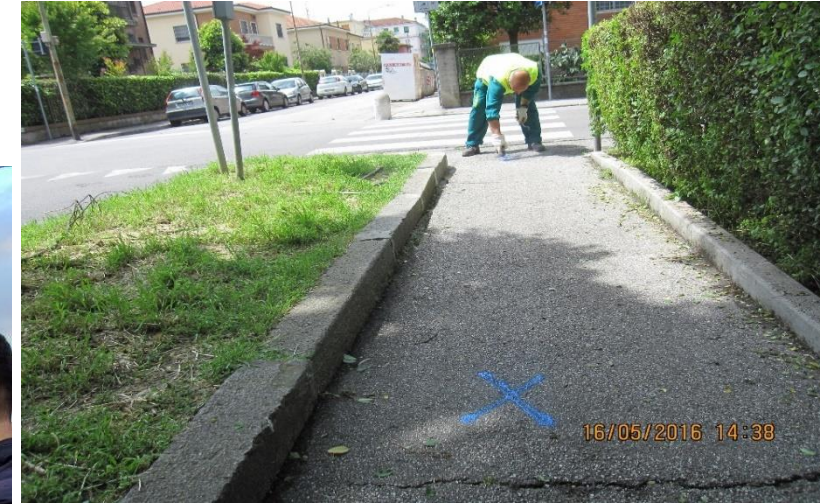
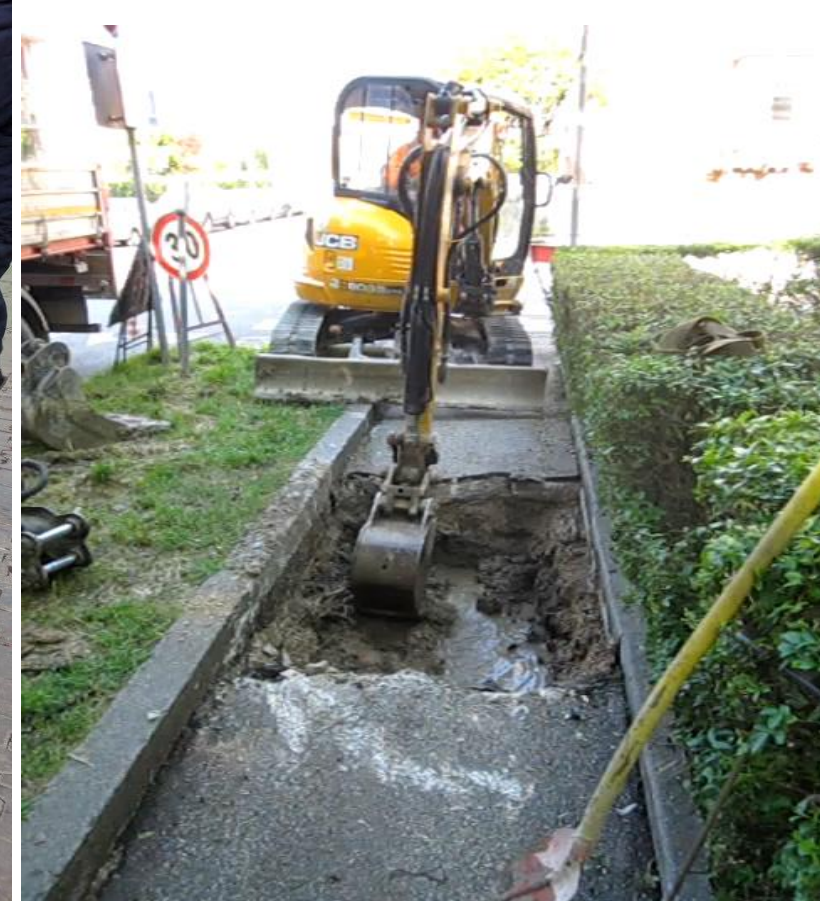
# Example step-by-step

**STW July 2018**  
**Finding: 10982**  
**110 Linton Rise, Nottingham NG3 7BY**  
**Image Date: 14-06-2018 Y: 52.95976, X: -1.11772**

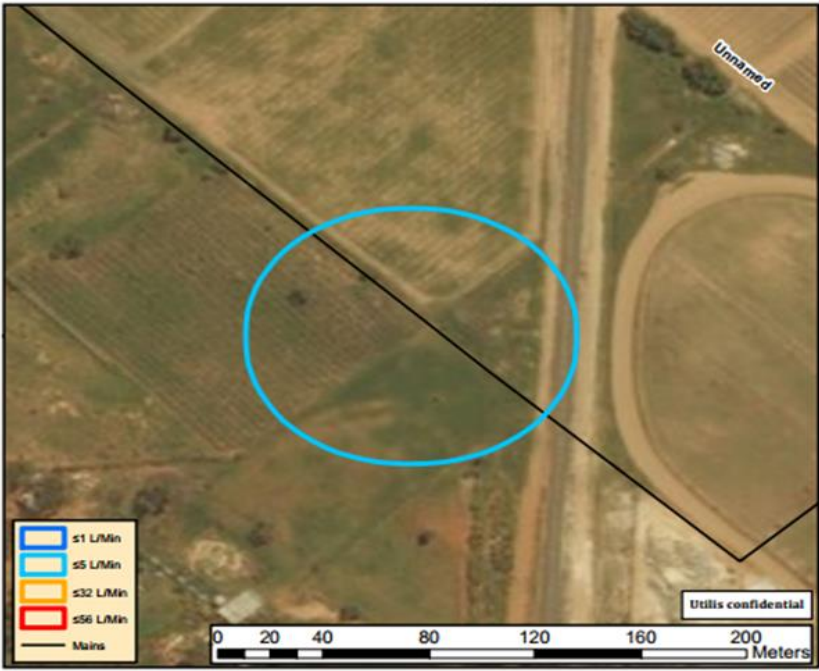
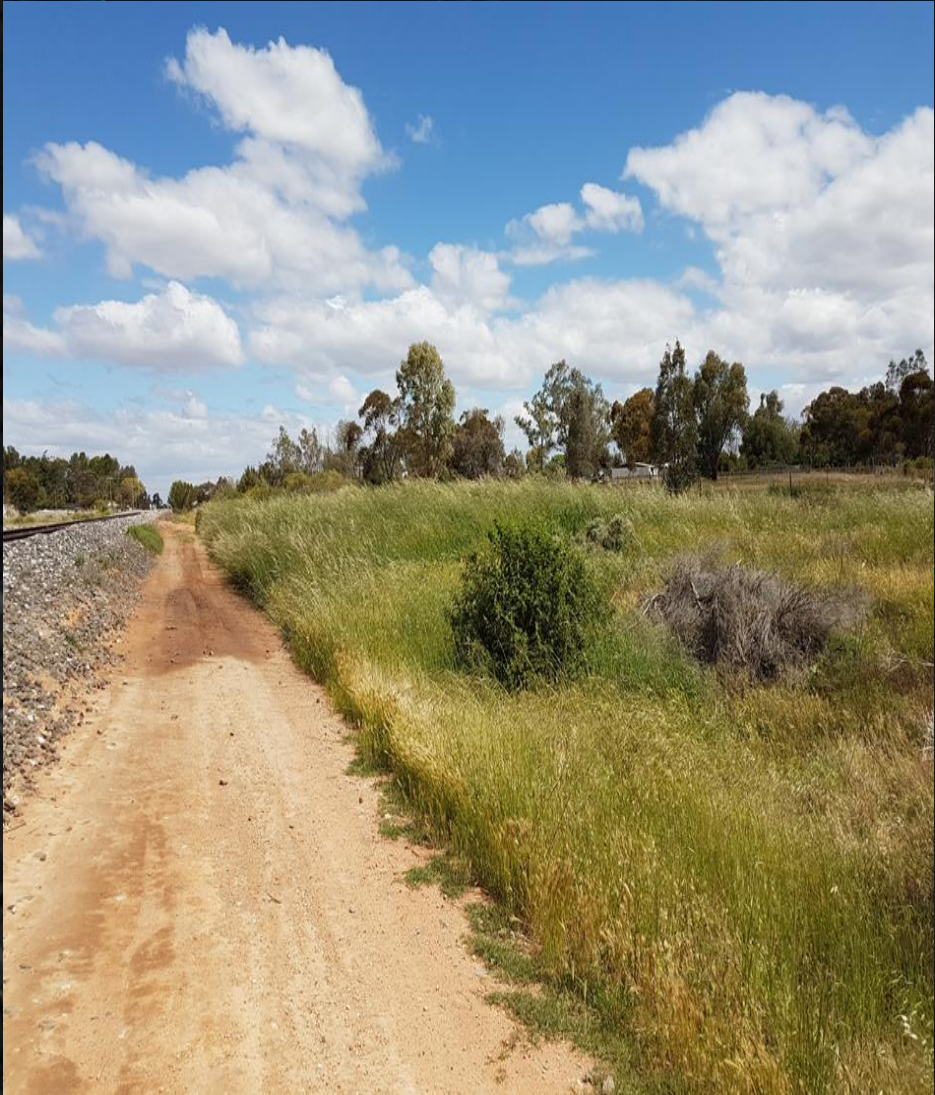
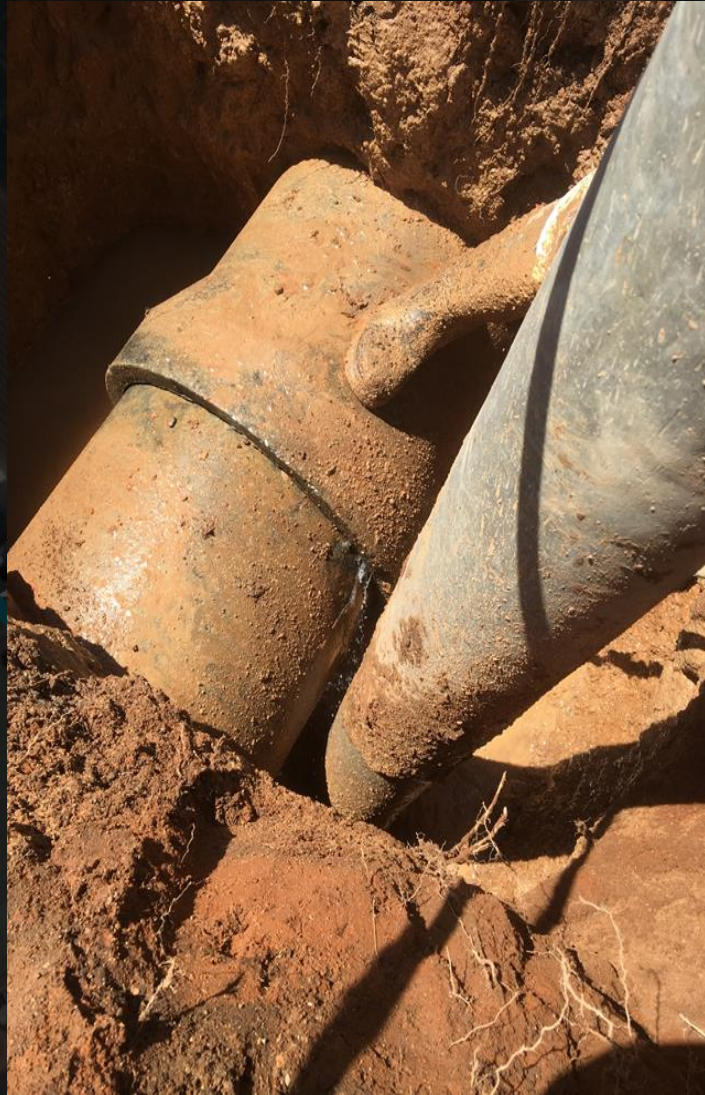
**Intensity (L/Min):** 20 (5.19) **Finding: 10107**

**Image Date:** 2723 Fourteenth Street, Irymple  
31-08-2016 **Postcode: 3498**

<b>Pipe Material:</b> RCP	<b>Leak Type:</b> <input type="checkbox"/> Main <input type="checkbox"/> Service <input type="checkbox"/> Residential	<b>Finding:</b> <input type="checkbox"/> Visible <input type="checkbox"/> Non-Visible <input type="checkbox"/> Suspect <input type="checkbox"/> Quiet	<b>Remarks:</b> _____ _____ _____
<b>Pipe Diameter:</b> 525	<b>Polarization:</b> HV Y: -34.214925, X: 142.171097		<b>IRR pipes</b>
